INVESTIGATION OF HYDROTEST FAILURE OF THIOKOL CHEMICAL
CORPORATION 260-INCH-DIAMETER SL-1 MOTOR CASE

By John E. Srawley and Jack B. Esgar

Lewis Research Center
Cleveland, Ohio

in Collaboration with the
260-SL-1 Hydrotest Failure Investigating Committee

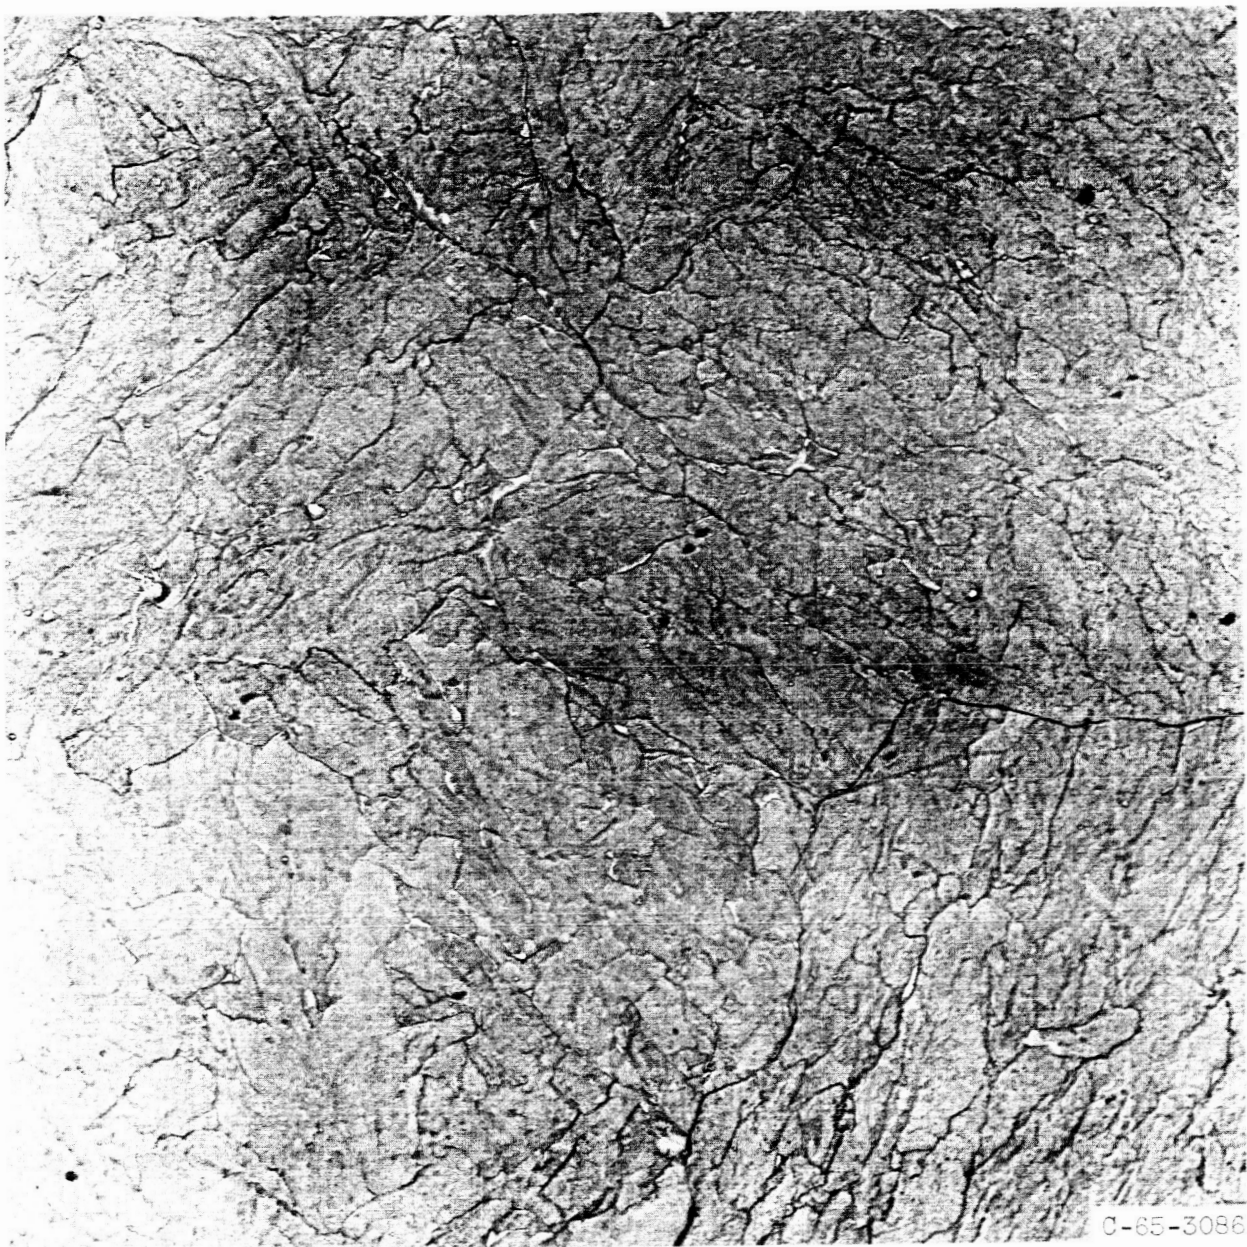
The HAZ of the base plate was examined at high magnification by replica microscopy; figure 30 shows typical areas near the black defect. The prior austenite boundaries - and to some extent, the martensite plate boundaries - show an enhanced etching characteristic and some evidence of second-phase particles, possibly austenite and/or TiC (ref. 6). These observations support the conclusion that the HAZ of the base plate experienced some embrittlement as a result of the thermal cycles that occurred during welding and weld repair.

Figure 30. - Replication electron micrograph of area near black defect (HAZ of base plate). $\times 10\ 000$.

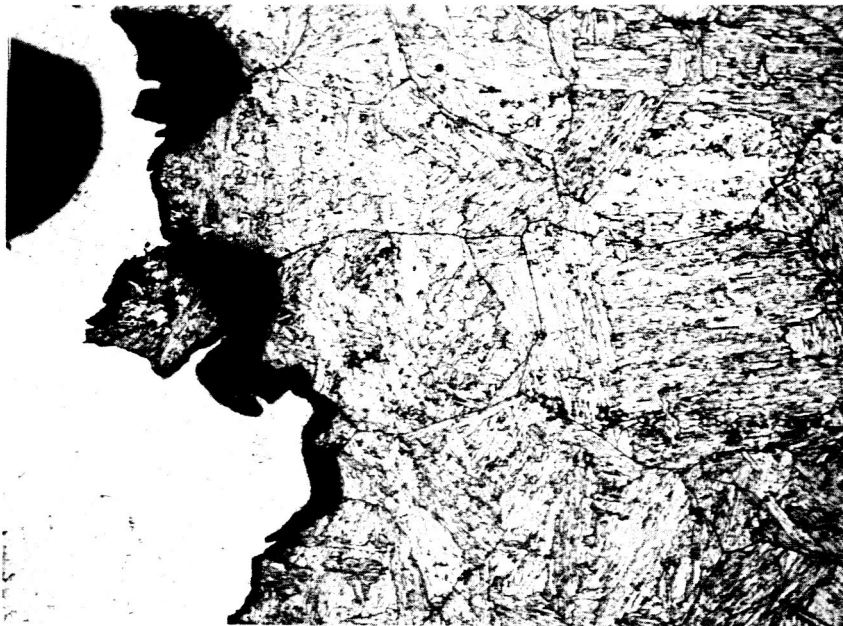
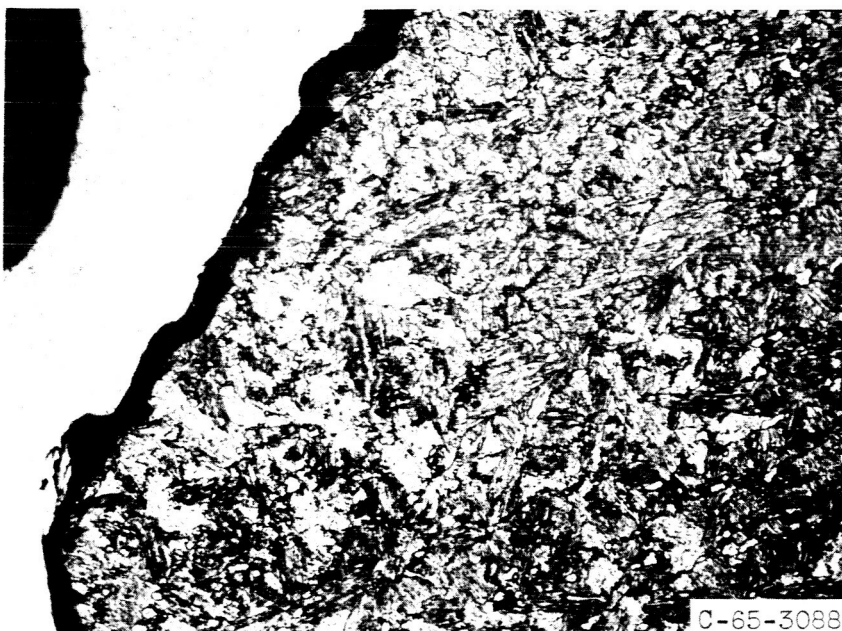
Fracture profiles (fig. 32) show a typical path followed by the main fracture through the midthickness region of the weldment (fig. 32(a)) and near the weld surface (fig. 32(b)). It is interesting to note that the fracture in the midthickness region occurred entirely in the grain-coarsened zone, just outside the subarc weld metal. The unusual path taken by the fracture suggests that this region possessed perhaps the lowest fracture toughness in comparison with other regions of the weldment, and consisted of an embrittled microstructure.

(a) Area 1 of figure 31.

(b) Area 2 of figure 31.

Figure 32. - Fracture profiles of fracture along weld
W7/302. x200.
